# Comparing various implant designs and surfaces

## A clinical study

**Authors** Roy Leshem D.M.D.<sup>1</sup>, David Leshem M.D.<sup>2</sup>

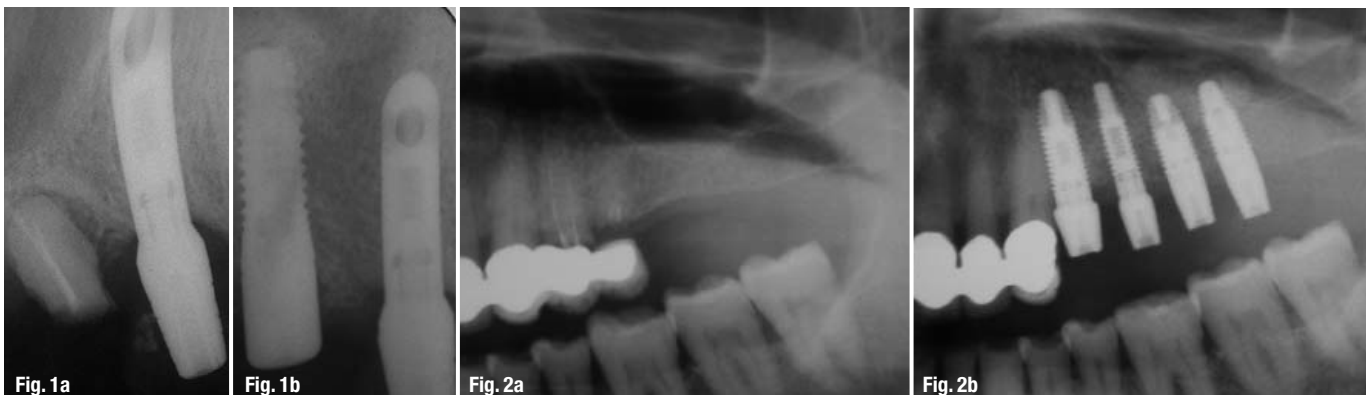
**Fig. 1a** Alveolar bone height 1 mm to sinus, before extracting second premolar.

**Fig. 1b** 13mm 4.2 thread implant placed with closed technique sinus augmentation.

**Fig. 2a** Alveolar bone height 3 mm to sinus.

**Fig. 2b** 11.5 mm 5.00 thread implants placed with closed technique sinus augmentation

The objective of the study was to present the success rate of fixtures of different designs and surfaces used in complex implant procedures, implants placed in internal sinus lift procedures (Figs. 1a–b), implants placed in lateral sinus lift procedures (Figs. 2a–b) bone augmentations, implants placed including grafting of buccal defect (Figs. 3a–d), and implants placed simultaneously with teeth extractions (Figs. 4a–d), all performed by one team. The retrospective study was conducted on patients treated at the Maxillary Facial Dept. of the Meir Hospital, Kfar Saba, ISRAEL and comprised of 144 implants consequently placed over a period of 4 years in 44 patients with partial or complete edentulous. Five

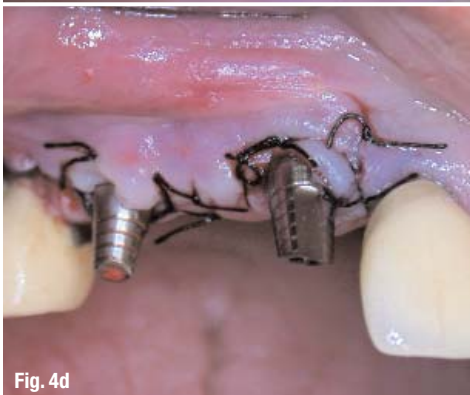
Fig. 4d

**Fig. 4d** Abutments placed on implants for immediate provisional restoration.
